#### SUMMARY OF OPERATIONAL EXPERIENCE FOR ADVANCED NON-LIGHT WATER REACTORS: MATERIALS AND STRUCTURAL INTEGRITY ISSUES

F.W. Brust, Engineering Mechanics Corporation of Columbus, Columbus, OH
M. Gordon, R. Iyengar, NRC, Washington DC
R. Turk, NUMARK Associates, Washington DC

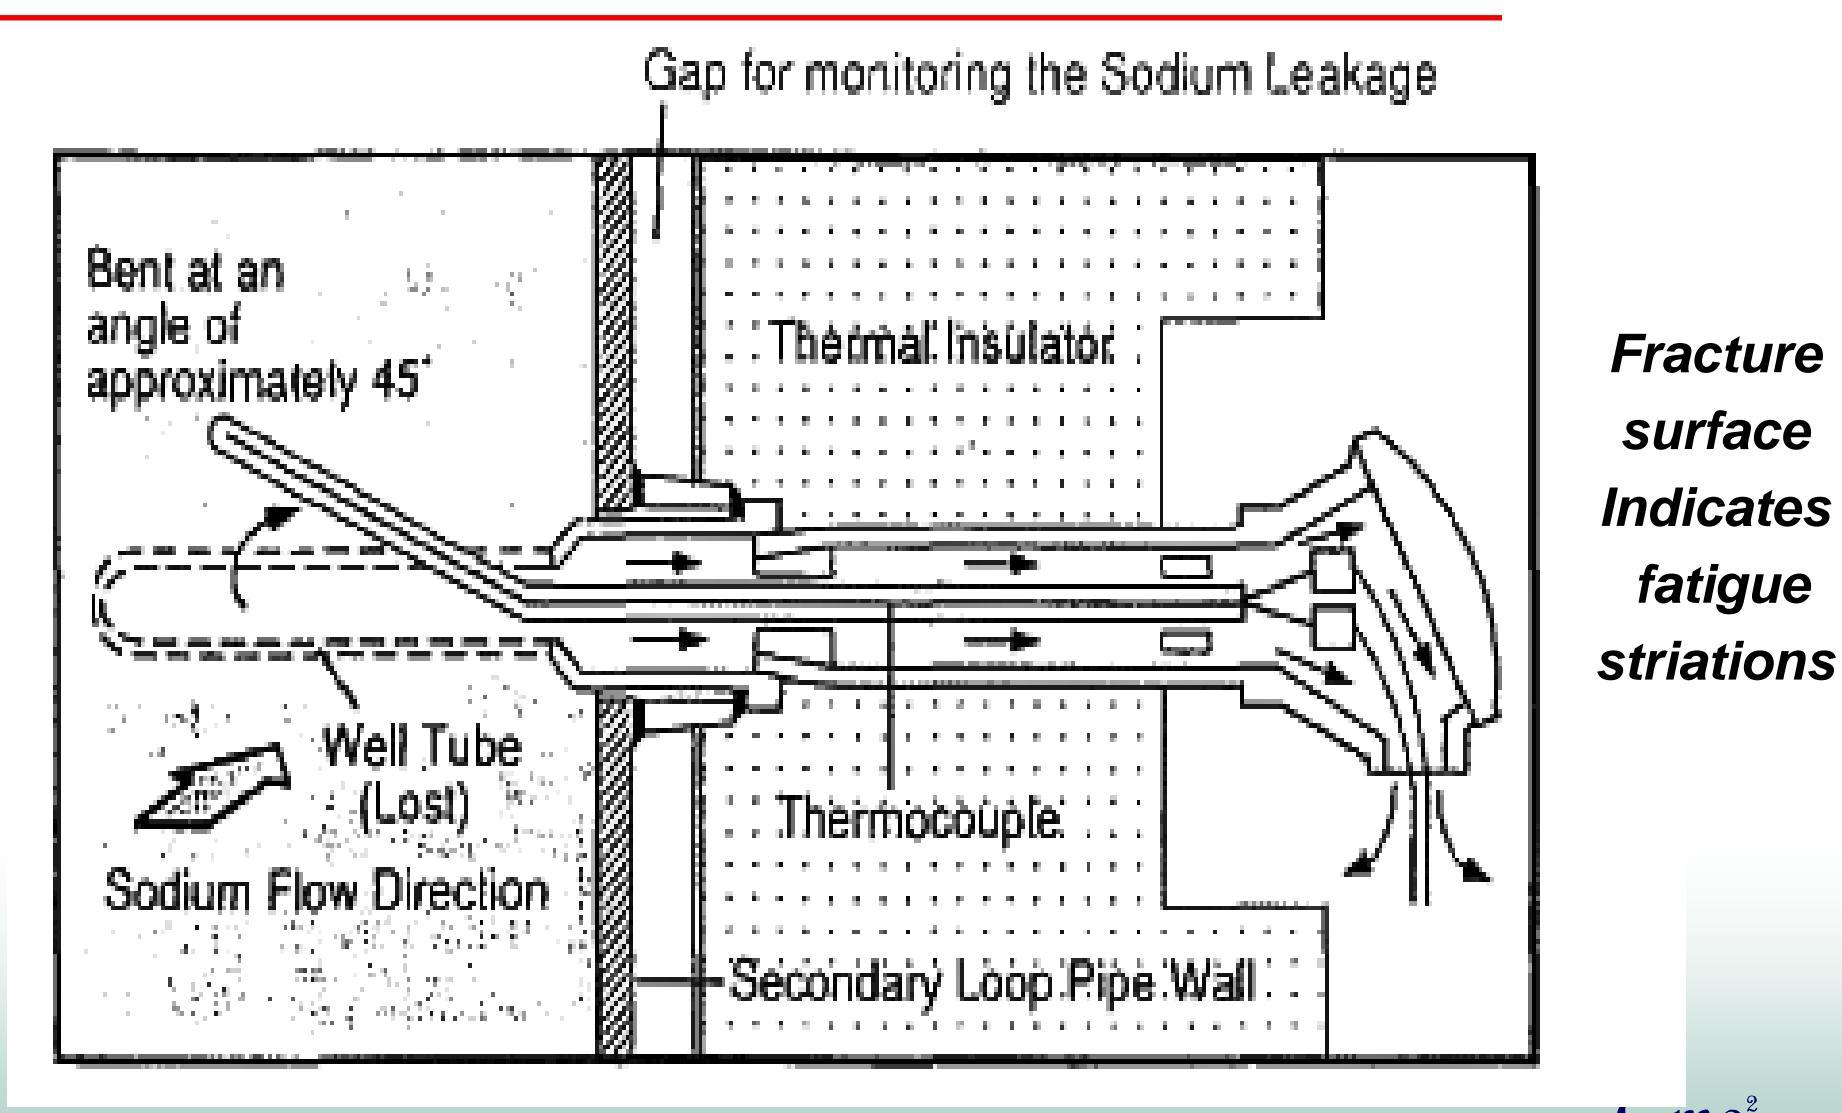
### **Examples: Monju Thermal Couple**

- After a scheduled shutdown and plant startup, a sodium leak occurred in the secondary heat transport system of pipe loop C (a hot-leg geometry)
- Led to a serious fire when it interacted with oxygen and moisture
- The leak melted steel structures in the room
- Located at a 3 mm diameter thermocouple penetration.
- The well tube failure was caused by high-cycle fatigue from flow-induced vibration caused by vortex shedding in the direction of the sodium flow

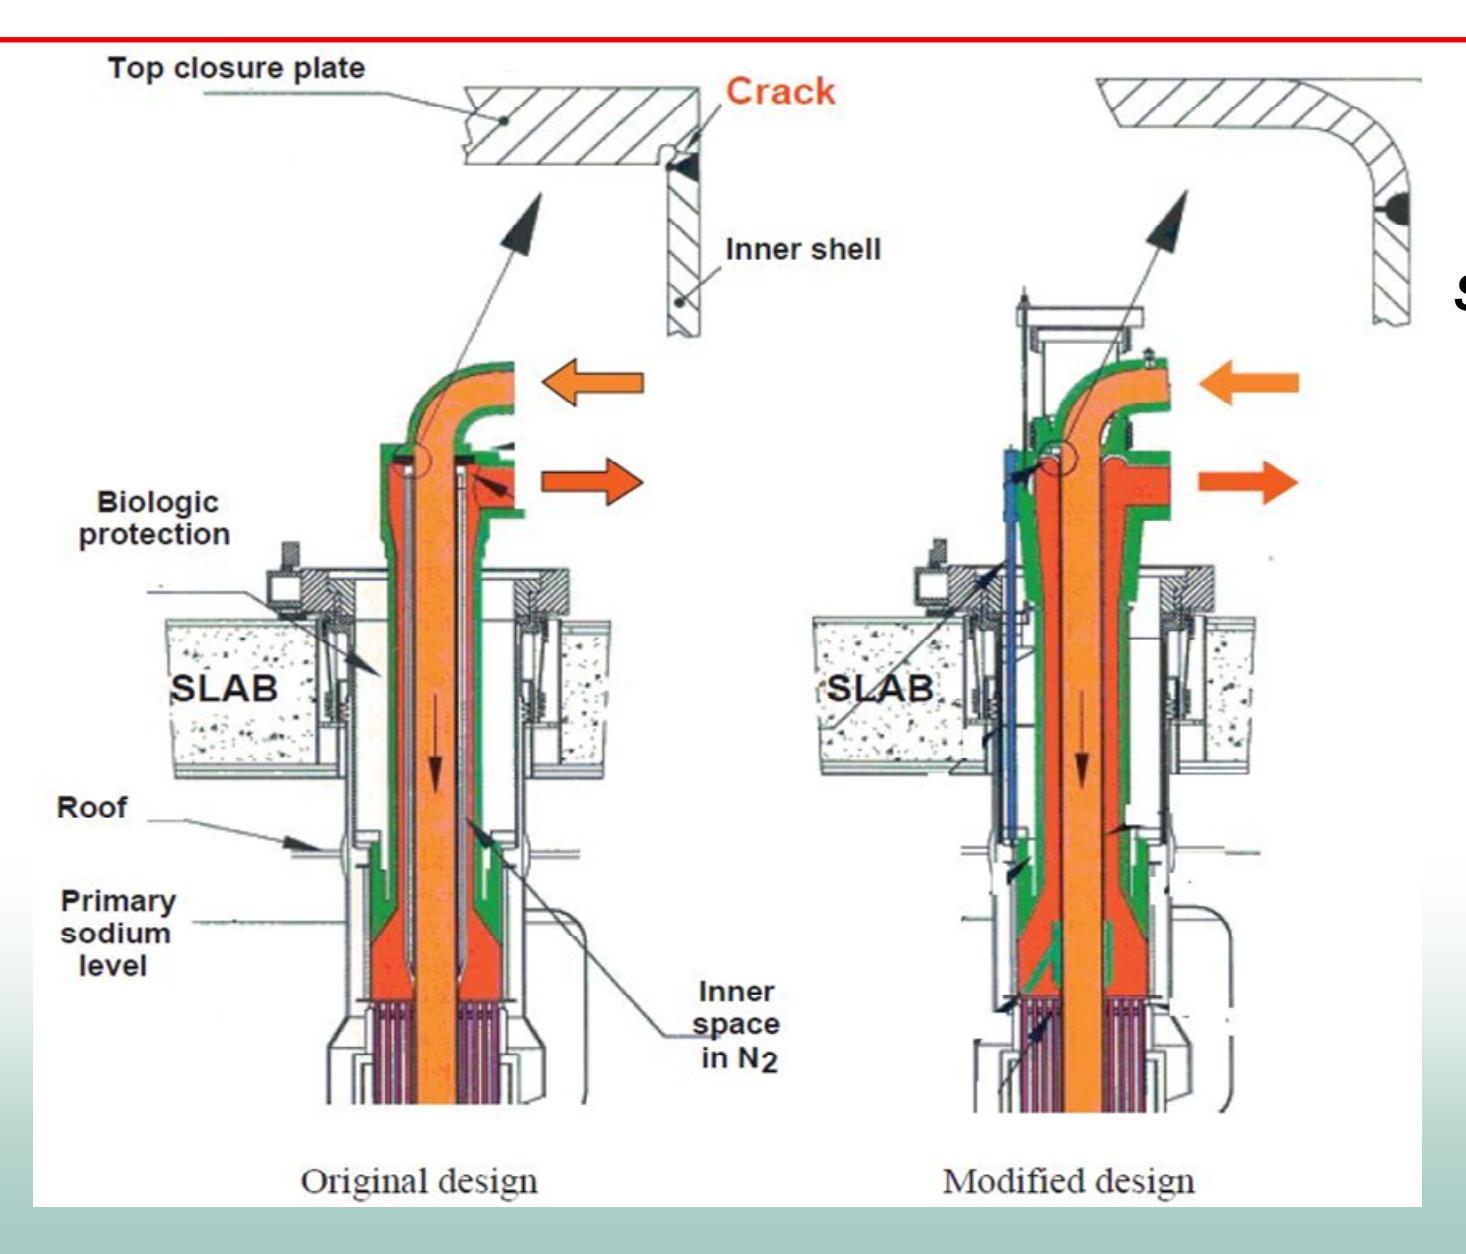
### **Examples: Phénix, general**

- Phénix experienced 11 sodium leak in 35 years
- These problems were solved using various design modifications
- A significant example is a sodium leak into the inner space at the secondary sodium outlet header
- Different thermal expansion loads between the inner and outer shells underestimated in the original design
- Solution; the redesign improved both the mixing of the secondary sodium outlet from the tube bundle and the flexibility of the IHX hot header between the top closure plate and the inner shell
- Control of structural constraints in SFRs in regions of thermal expansion mismatch is an important design feature and must be considered during the license assessment of the plants

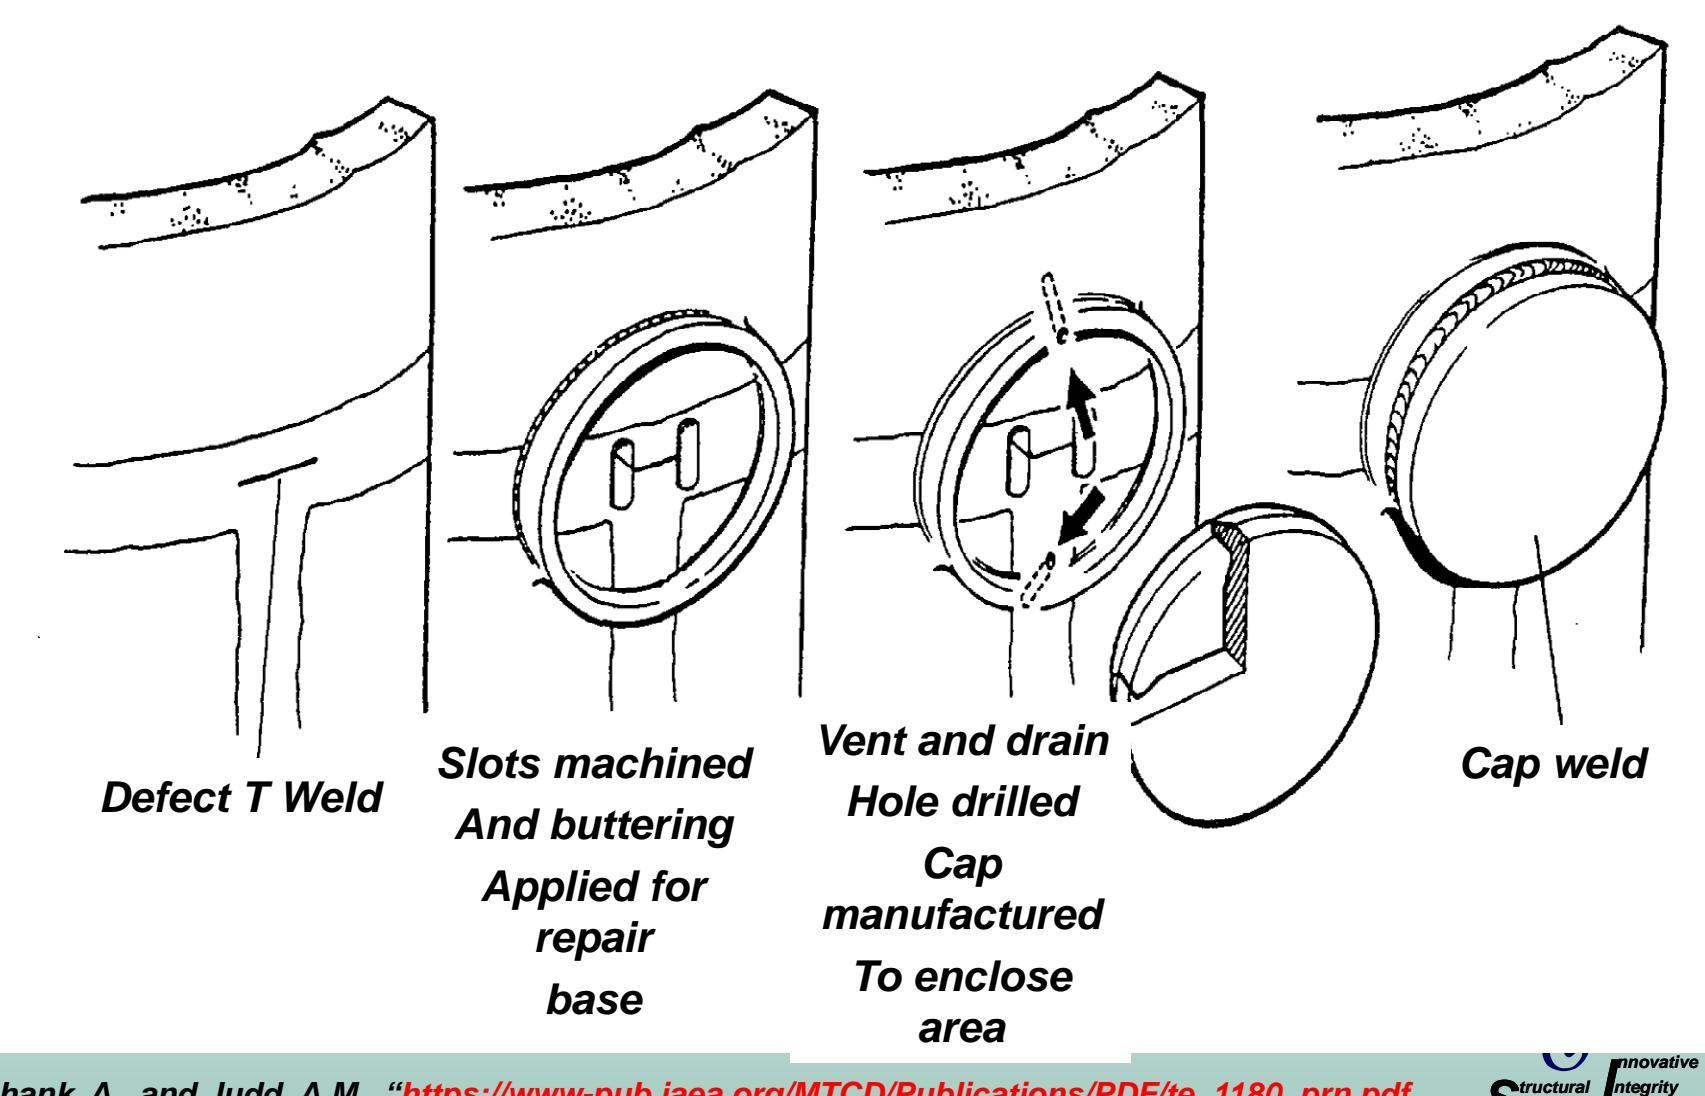
## Examples: PFR, general

- Cracking in PFR SG containment vessels was observed during maintenance activities
- Delayed reheat mechanism driven by residual stresses in non-stress-relieved welds initiated cracking in PFR SGs
- Weld repairs made during manufacturing gave rise to conditions that favored cracking
- Weld residual stresses must be properly managed in systems where creep may occur and where corrosion may take place

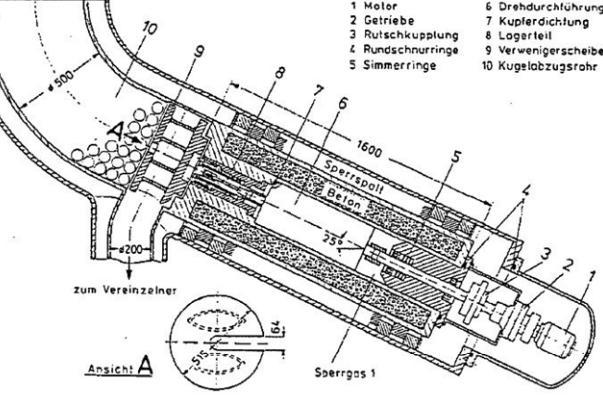
# **Examples: AVR, 1971-1981**

- Slowly rotating slotted double disk moves fuel pebbles move through the disk and down the pipe
- As the disk rotates, the pebbles are statistically distributed into the core.
- January 1971, internal friction cause drive motor to fail
- October 1974, a drive cam shear failure
- July 1976, the bearing shield became loose
- August 1976, a feather key sheared off in the reducer drive, stopping the reducer entirely
- December 1981, the drive no longer turned because of corrosion caused by water condensation
- The repeated failure of the reducer can be attributed to poor design

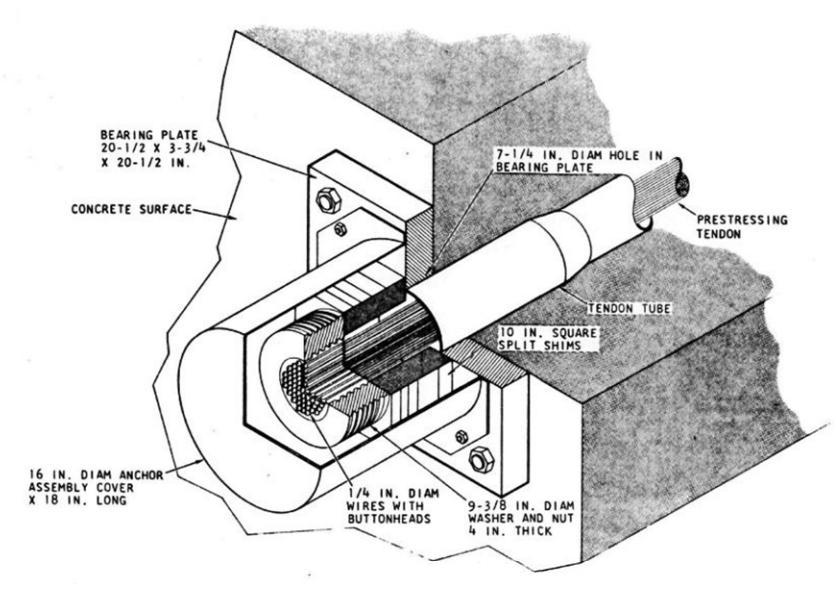
## Examples: FSV, 1984

- The PCRV tendon wires corroded
- PCRV: 448 tendons, each 3.87 meters wires
- Load cells were used to detect any loss of pre-stress
- The licensee found six broken tendons
- Tendons are stored in sealed boxes: preventing moisture ingress
- Pre-stress produces compression in the PCRV liner
- Sulfonate grease used on the tendon wires combined with oxygen from air ingress created acetic acid, corroded the tendons
- PCRVs are subject to degradation mechanisms that traditional RPV steels do not encounter in service
